Wire Get Out of Right Foot after Enteral Venous Atheterisation

Abstract

Case presentation: A 29-year-old female patient with only symptom of pain and burning in plantar side of her right foot with guide wire emerging out through the plantar side of the right foot about two years after central venous catheterization. There were four wire fragments that one of them protruded through the skin, two wire fragments were removed by using trefoil endovascular snare and one fragment moved to the surface and removed by a small incision.

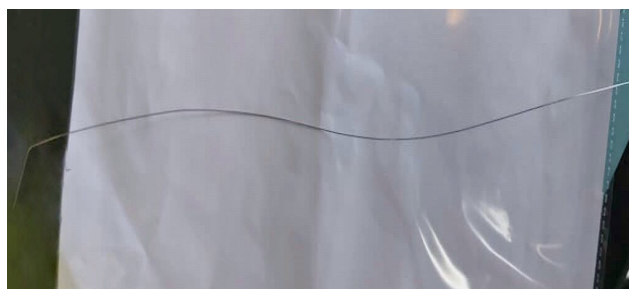
Figure 1 Removed guide wire that was protruding out of the skin on the plantar side of the right foot.

Eventually, the patient got cured after 6 days of hospitalization, the platelet count rose and she discharged. On the current admission to the surgery department of our institution, physical examination was unremarkable except for a guide wire that was present protruding out of the skin on the plantar side of the right foot (**Figure 1**).

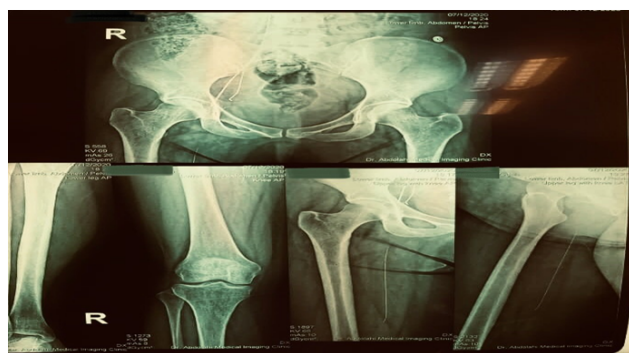
Figure 2 X-ray pelvis with bilateral hip showing bent wire fragment in right side of the pelvic inlet X-ray right hip with proximal femur showing wire fragment on the medial side of the right.

X-ray PBH, X-ray right hip with proximal femur, showed absent radio opaque wire fragment on the right side of pelvic inlet measuring approximately 30-40 cm, presence of another wire fragment on the medial side of the right upper thigh, was also noted (**Figures 2 and 3**).

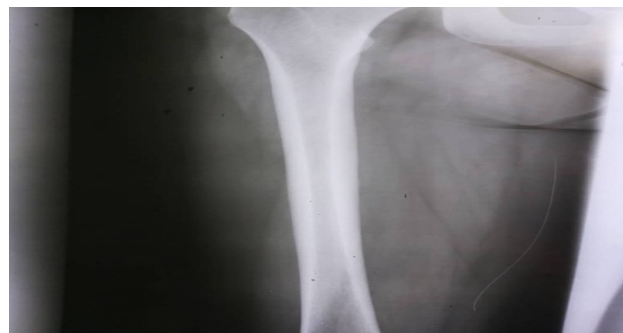
Figure 3 X-ray right hip with proximal femur showing wire fragment on the medial side of the right upper thigh.

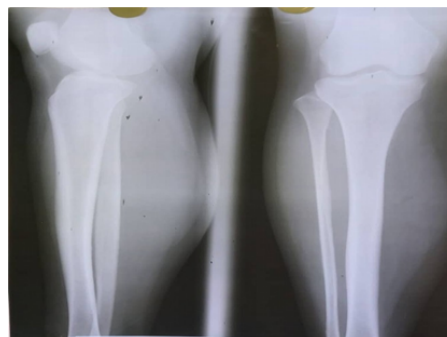
Figure 4 Anteroposterior and lateral X-rays of knee are not showing any guide wire fragments.

X-ray right knee, X-ray right lower leg did not report any guide wire fragment (**Figures 4 and 5**). Chest X-ray showed that the hook-like distal end of the guide wire (measuring approximately 4 cm) had broken off and extended upward travelling through the Inferior Vena Cava (IVC) and passed the right atrium and

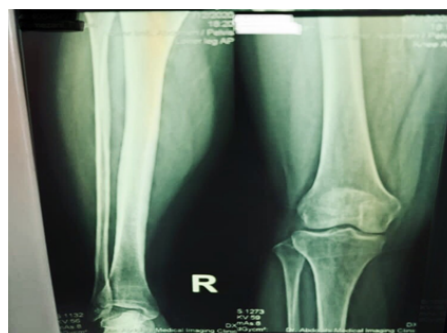
Figure 5 Right lower leg X-ray of knee are not showing any guide wire fragments.

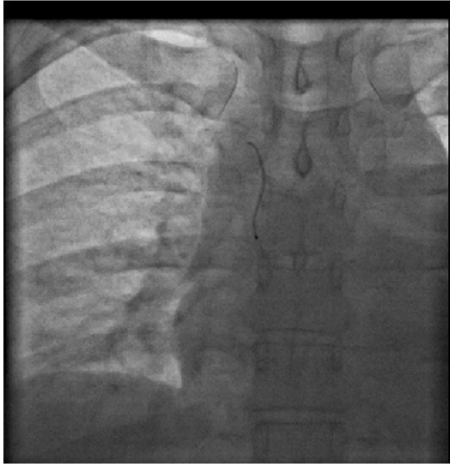
Figure 6 CXR showing hook-like distal end of the guide wire in the SVC at the level of fifth intercostal space.

surprisingly finally terminated in the Superior Vena Cava (SVC) at the level of fifth intercostal space (**Figure 6**).

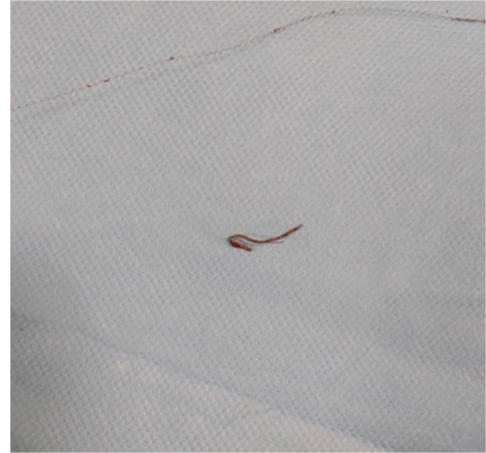
Figure 9 The hook-like distal end of the guide wire removed from SVC.

Secondly, the Trefoil En-Snare using the left femoral venous approach was guided toward the right atrium and the retained fragment in SVC was easily detached, measuring approximately 4 cm (**Figure 9**).

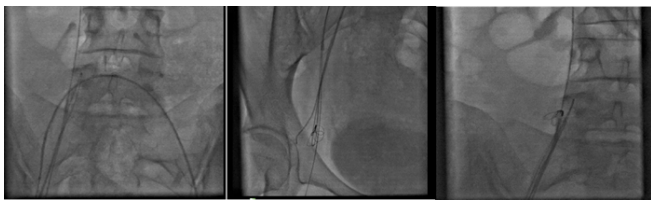
Figure 7 Wire removal of Right Iliia vein.

Surgical extraction of the guide wire fragments in the right Iliac vein and SVC, was performed in Cath lab. Under fluoroscopic guidance using a left femoral venous approach, the removal of the retained wire fragments was attempted with a Trefoil En-Snare by the interventional cardiology team.

At first, the retained fragment in the right Iliac vein was removed. It was captured with the snare, which was guided from left femoral vein and was pulled out totally through the snare catheter, despite the weak adherence to vascular wall, measuring approximately 30-40 cm. (Surprisingly the length is more than a normal guide wire) (**Figures 7 and 8**).

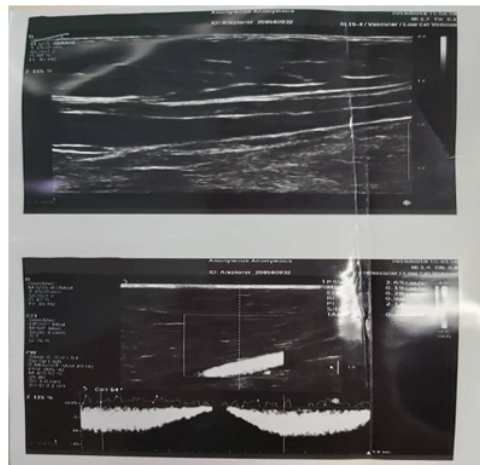
Figure 10 Ultrasonography showing presence of wire fragment in the soft tissue.

The fragment guide wire which has been in thigh, was not noticeable during venoangiography, according to that, we recognised it had been either in soft tissue or femoral artery, and not in the femoral vein, so that ultrasonography was done. It showed that the fragment had been in the soft tissue (**Figure 10**).

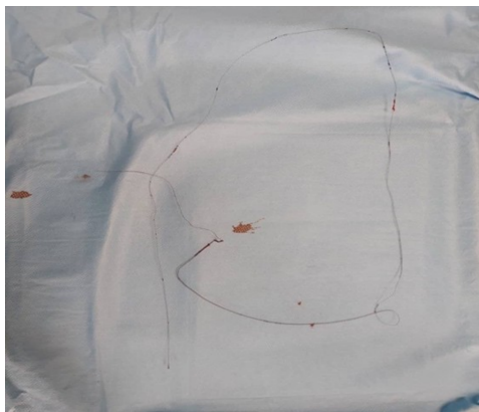
Figure 8 The wire fragment removed from right ilia vein measuring approximately 30-40 m.

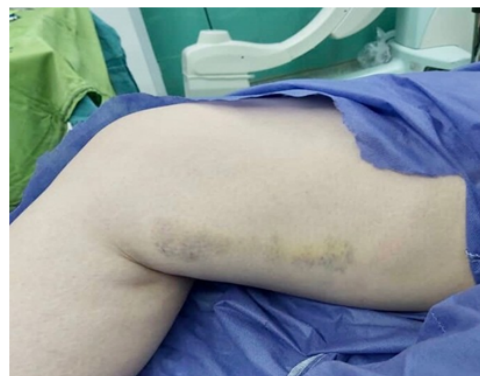
Figure 11 Skin of the medial side of the right thigh bruises.

After one month, the fragment had been moved to the surface, skin surface was bruised and the wire could be touched under the skin (**Figure 11**). By the end, the last part (measured approximately 15 cm) was removed by a small incision (**Figure 12**).

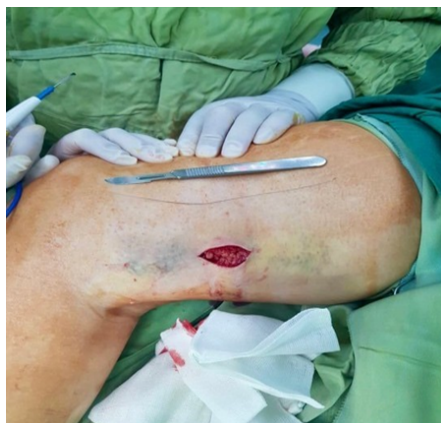
Figure 12 Showing removal of a guide wire fragment (measured approximately 15 m) from the soft tissue of the medial side of the right thigh.

We noticed, the second theory was correct and the core wire was stuck in the right pelvic whereas the spring coil art was in soft tissue on the medial side of the right upper thigh.
